# Field Study

## UWX550 compressor

March 2011

Cat. No. T1103

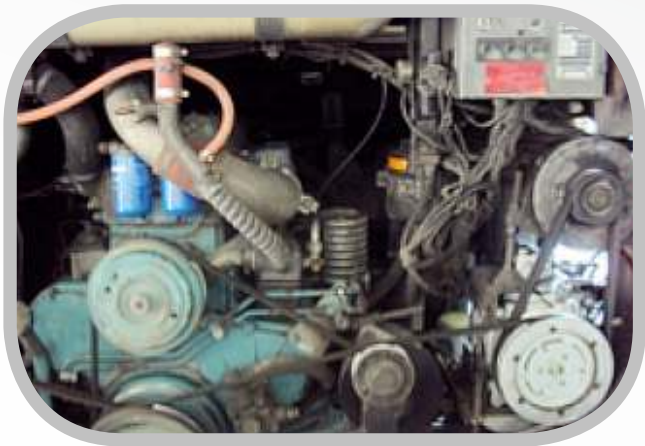
Engine bay.

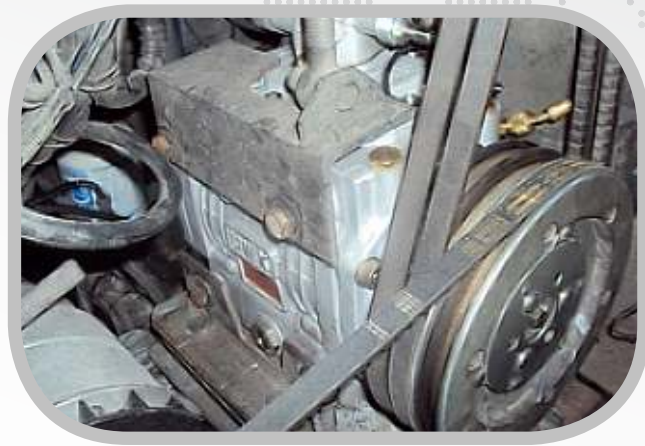
Custom compressor mount bracket and 3B clutch pulley.

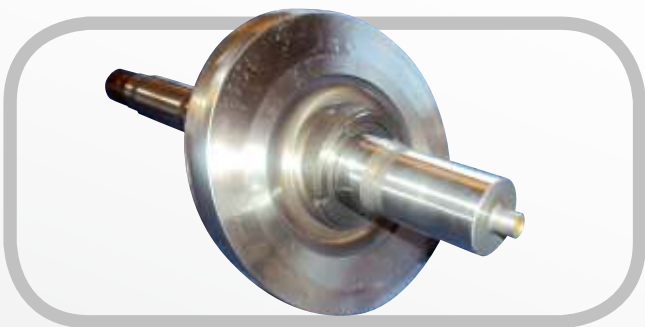
### Swashplate

**Clearance:** 0.05 mm (Standard: 0.020 – 0.022) This enlarged clearance (endplay) was due to normal wear on the contacting surfaces between cylinder and thrust washer. Only some slight scoring was found on the front thrust washers. This would not affect the running operation and durability of the compressor, or create any abnormal vibration or noise.

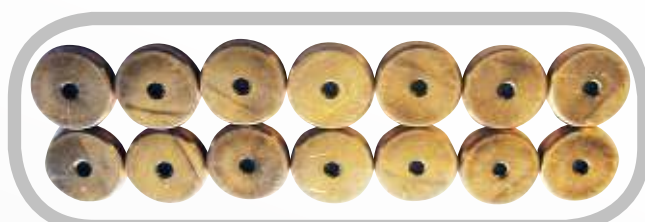
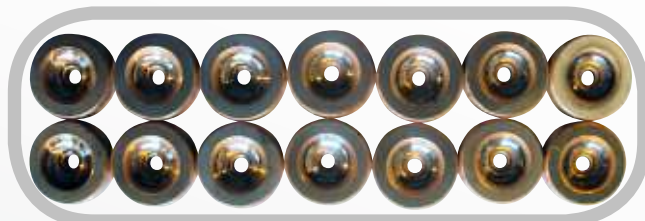
### Shoe discs

The sliding sides of the shoe discs were in good condition and within specification for their age. There was no damage to other parts of the discs and they could continue to function normally.

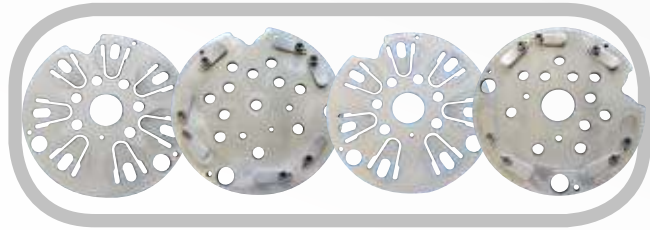
### Valve plates

All valve plates were in excellent working order. There was no sign of excessive temperature or pressure during operation, with only some slight scoring on the discharge plate for the oil pump gear.

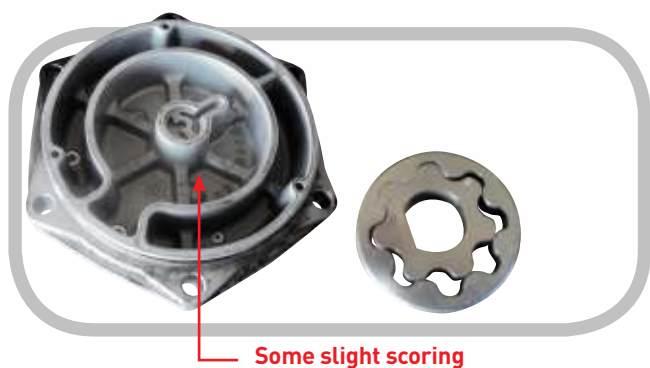
### Rear cap and oil pump

Some slight scoring of the oil pump gear housing in the rear cap was found, plus some scoring of the thrust bearing washers. The pump housing was the most likely the source of the small metal particles found in the receiver drier filter, but the thrust bearings and oil pump operation were otherwise still within specification.

The rear cap and oil pump were both in good condition, with the rear cap showing some slight scoring in the oil pump chamber.

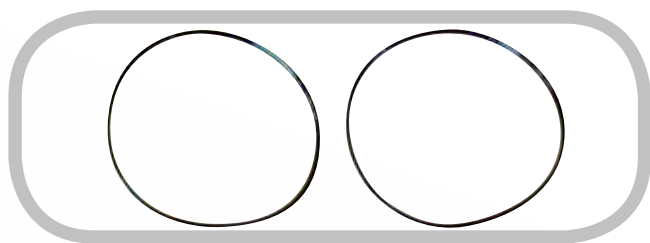
### Front and rear cap O-ring

Both in good condition with no abnormalities.

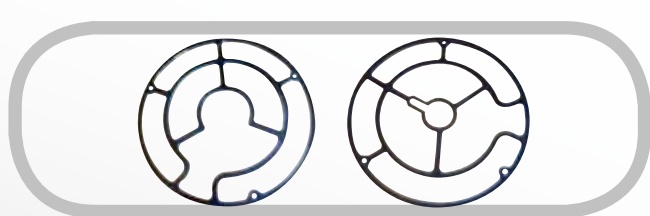
### Front and rear gaskets

Both in good condition with no abnormalities.

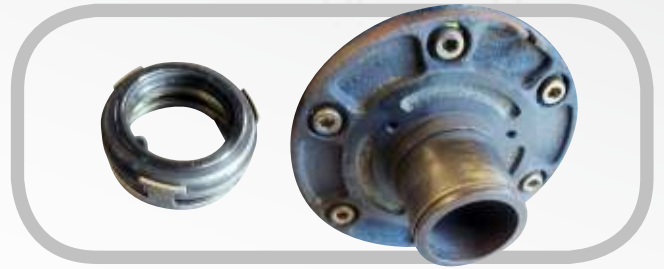
### Front nose cone and shaft seal

Both in good condition with no abnormalities.

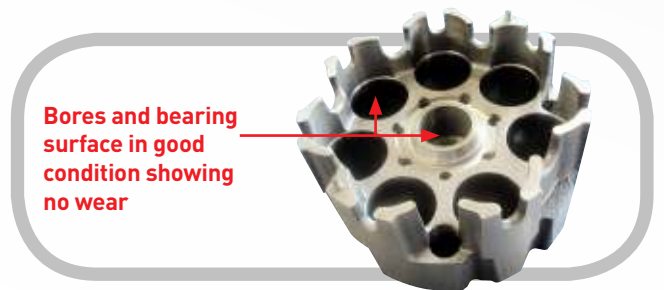
### Cylinder housing

Showing no excessive wear on bores and bearing surfaces.

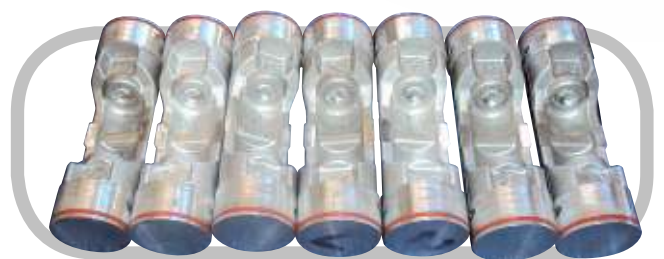
### Pistons and ball bearings

All in good condition with no sign of excessive wear or chaffing.

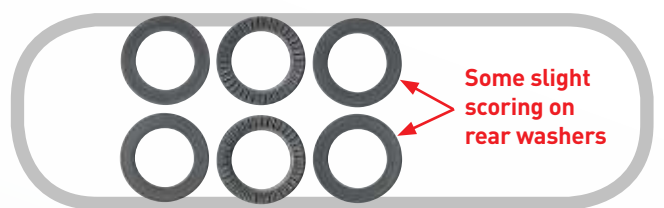
### Thrust bearings and spacers

Showing normal wear with some slight scoring in the rear washers.
