# UP115 compressor

Unicla Cat. No. T1701

An intense inspection was carried out on this compressor by the Unicla Australia team after they had been informed about a faulty system by A1 Auto Electrics & Airconditioning in Moree, NSW Australia.

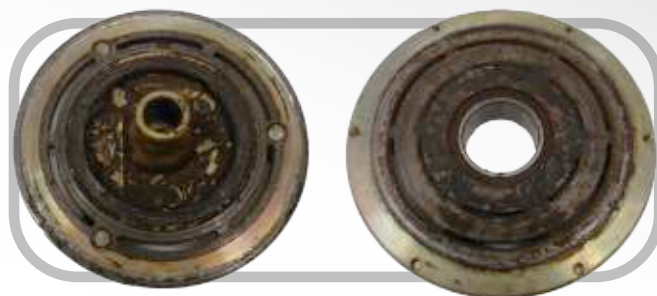
The clutch system was fine mechanically, however as it can be seen in images over a long period of time, a lot of mud and grime had worked its way between the armature plate and the pulley surface and had then jammed, effectively gluing the plates together.

The armature was jammed against the pulley by solidified mud and grime

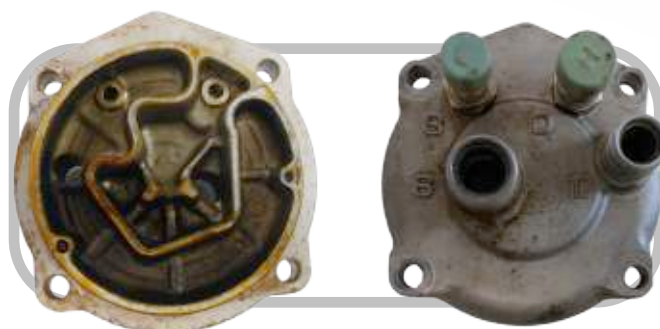
Rear cap

The leak test also indicated that the compressor port or rear cap was not leaking and the actual leak was later found on the hose side of the connection.

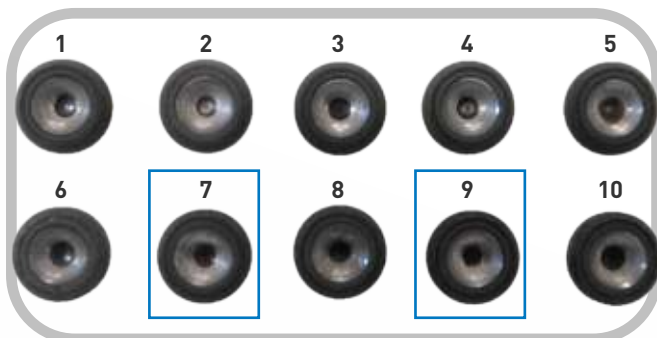
The thickness of the shoe discs normally are manufactured in the mid-range of 3.55mm. Considering the high working hours and conditions, and the fact the compressor was operating with low levels of gas and oil, caused by the offending gas leak on the suction hose, the wear was acceptable with only 2 of the 10 shoe discs showing out of tolerance wear (marked in red table below).

All shoe discs were slightly worn with number 7 and 9 reaching an out of design tolerance

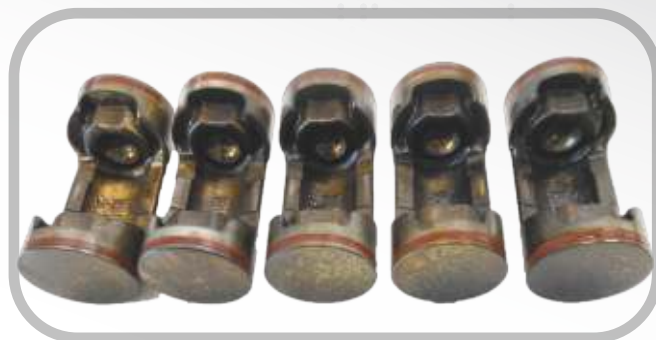
Pistons from the compressor

The cylinder housing compression chambers and the pistons were showing average wear of only 0.05mm, which is an excellent result considering the life of compressor. This confirms Unicla's claim that the compressors maintain their compression after very long periods of use.

The piston ring and body measurement results (in millimetres) in table 2 show the minimum wear that has occurred on these parts since the time of manufacture of the compressor. Pistons originally measured 30.52mm and rings 30.47mm.

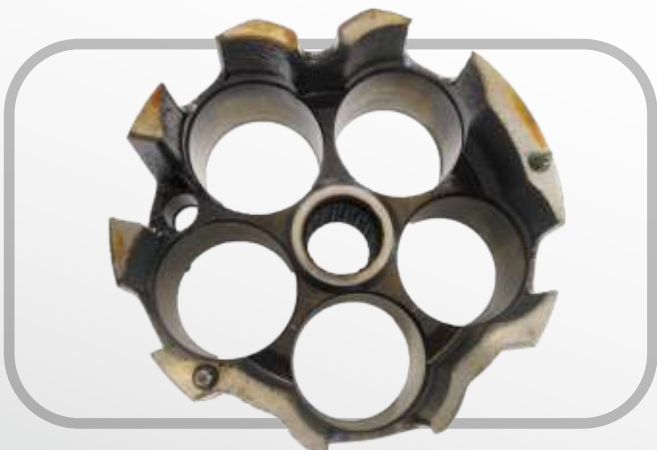
Cylinder housing

All internal components displayed signs of fatigue and overheating, but the compressor was still operational. The extreme overheating was caused by the low refrigerant flow and lack of compressor cooling.

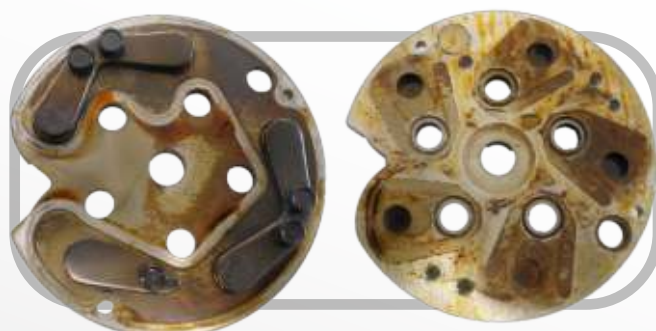
Clear sign of overheating on valve plates
