# UPF170 compressor

Cat. No. T1702

This report reveals the high temperature levels in the system caused from the low refrigerant conditions and how it impacted on the compressor. The main components affected are the shaft seal, rear cap housing and the rear oring. The final leakage at the heat fatigued oring resulted in the replacement of the compressor after six and a half years of service and 355,000km.

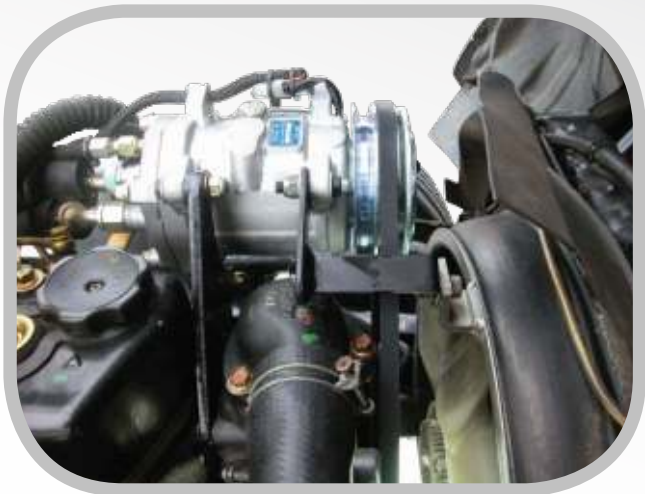
Compressor mounted to engine.

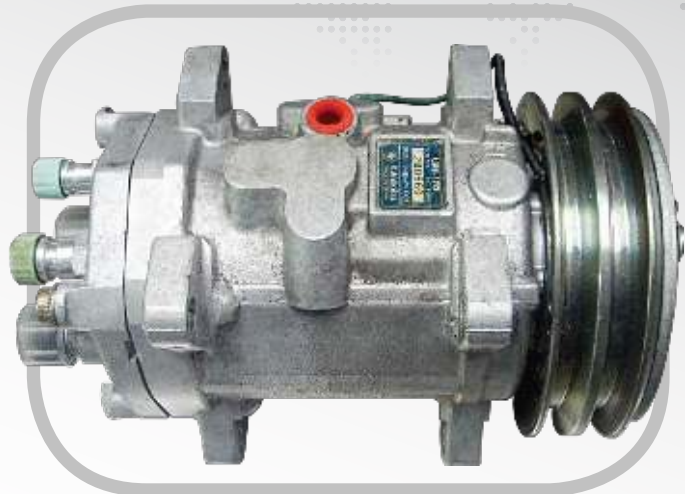
Actual UPF170 compressor.

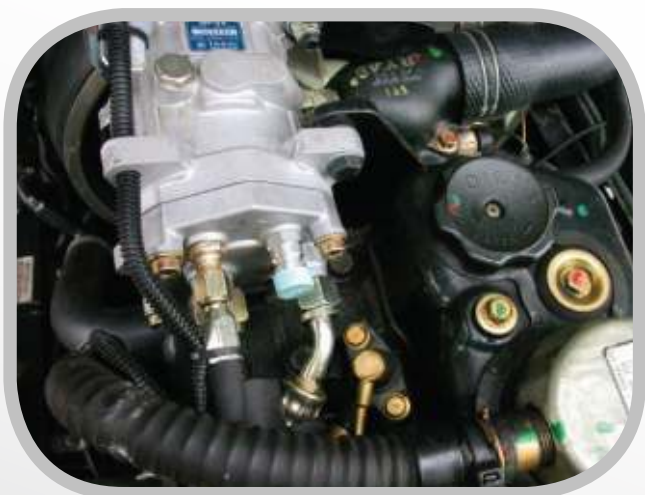
Rear view with horizontal refrigerant hose connections, plus oil return line fitted in place of suction service fitting to rear cap.

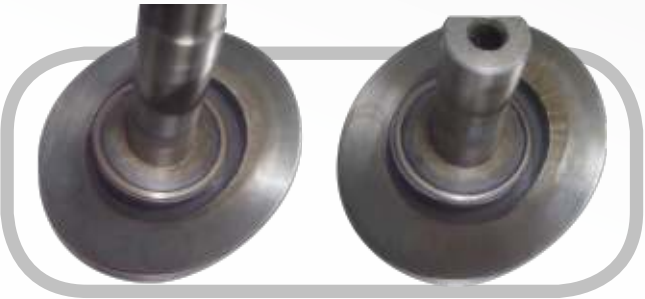
Front and rear surfaces of swashplate

**Clearance:** 0.150 mm (Standard: 0.020 - 0.022). This enlarged clearance (endplay) is due to normal wear on the contacting surfaces between cylinder and thrust washer. No damage was found on these surfaces or the thrust washers. This would not affect the running operation and durability of the compressor, however may cause a slight noise.

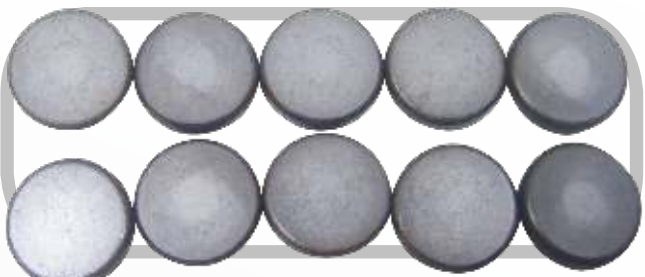
Shoe discs

**Clearance:** (Standard: 0.020 - 0.022). The sliding sides of the shoe discs are in good condition and within specification for their age. No damage to other parts of the discs and they could continue to function normally.

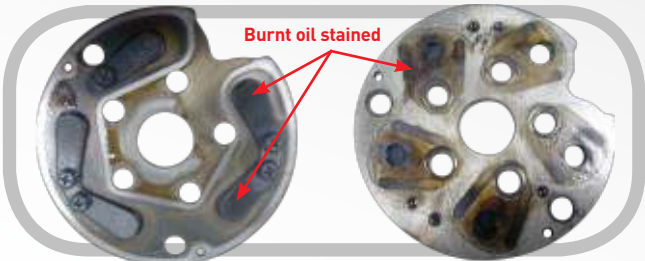
Front discharge valve plate assembly (front & rear)

All valve plates are in normal working order. Burnt oil stains are evident which is most likely caused from excessive temperatures during operation with low gas. Rust is evident on the rear discharge valve plate, however this has appeared from exposure to air and moisture after removal from the system.

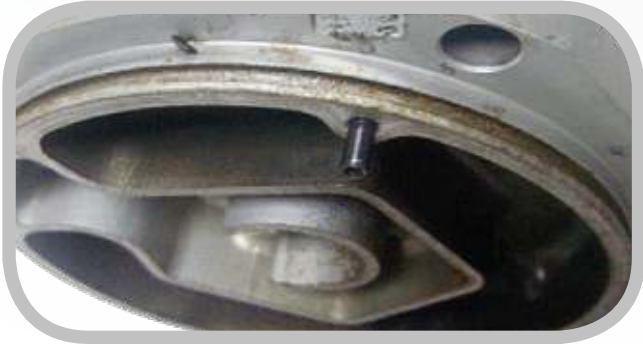
The rear cap is still in good condition, however the inside section had black and burnt oil stain on both high pressure and low pressure chambers. The high temperatures causing this condition have also contributed to the oring stress on rear cap, causing the oring to break its seal (see photos on this page).

Oring groove is dirty

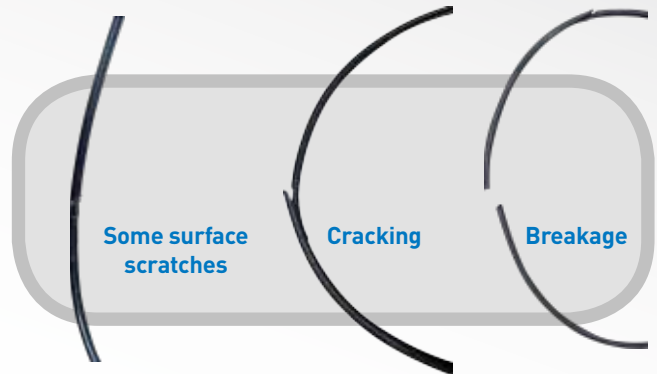
Inspection on rear cap oring. The oring groove on the rear cap is dirty with burnt oil and oring deposits turning to carbon from excessive heat. Sections of the oring have hair line cracks caused from the removal and inspection process (oring is slightly brittle).

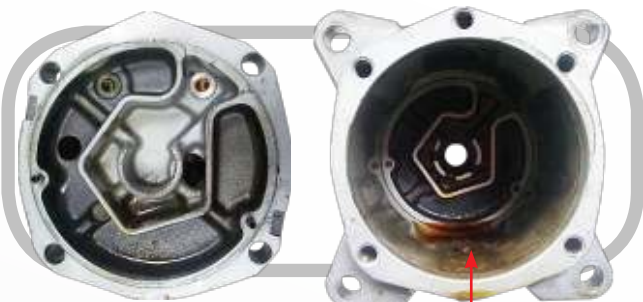
Remaining burnt oil

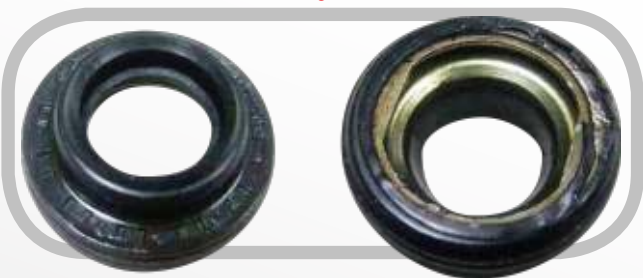
In good condition with no abnormalities. Installed in November 2006.

Shaft seal - no abnormalities

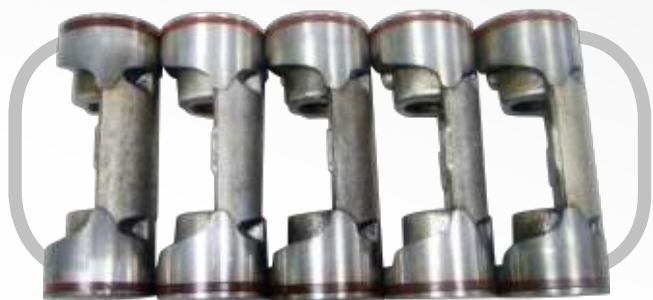
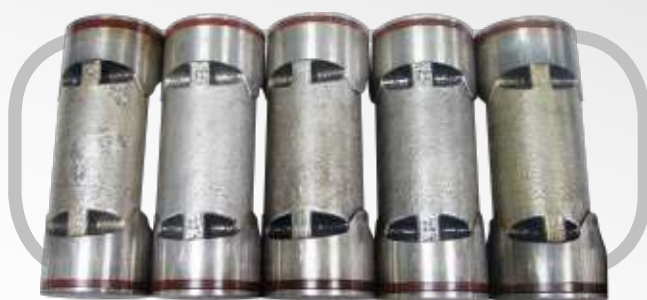
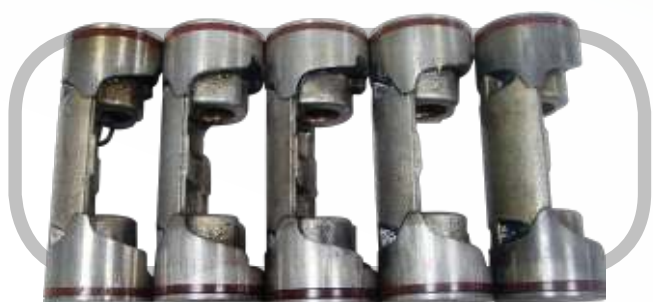
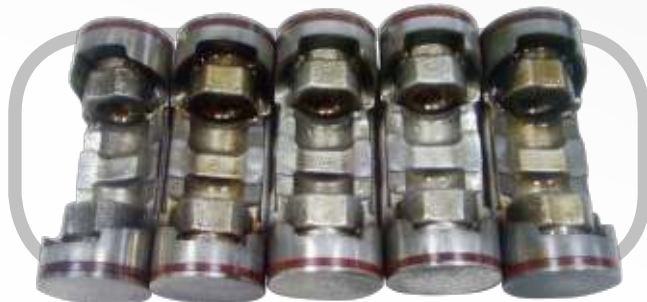
## Pistons

All in good condition, showing slight chaffing.
