# Field Study

## UWX550 compressor

Surfers Paradise Coaches Australia

February 2018

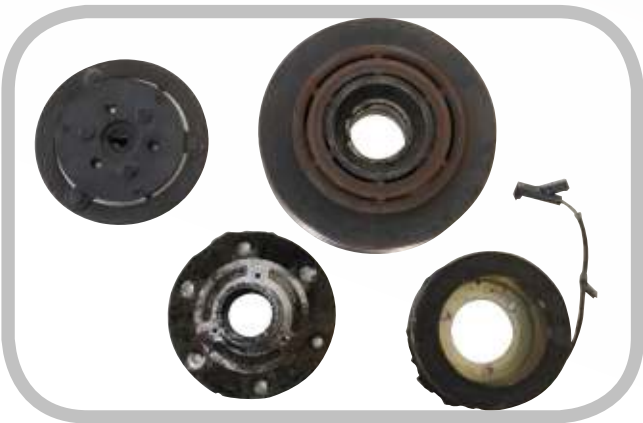
Clutch set

The clutch system was fine mechanically, however, as it can be seen in the images, over a long period of time dirt and grime had worked its way between the armature plate and the pulley surface. The clutch pulley also appeared to have diesel oil soaked over it but the pulley was still smooth and tight, and operating satisfactorily. With new bearings and a clean, the clutch could be returned to service.

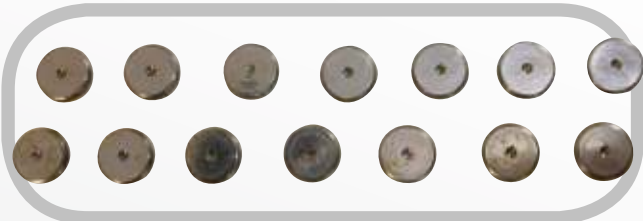
Shoe discs

The sliding sides of the shoe discs were in good condition and within specification for their age. There was no damage to other parts of the discs and they could continue to function normally. The measurements can be found in the below table.

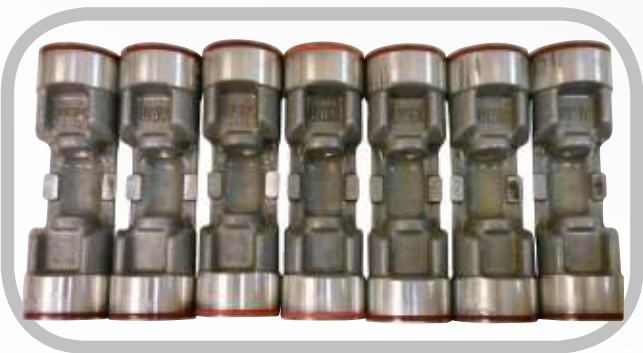
Pistons from the compressor

The cylinder housing compression chambers and the pistons were showing minimum wear, which is an excellent result considering the life of compressor. This would confirm Unicla engineers' claims that the compressors can maintain their compression after very long periods of use.

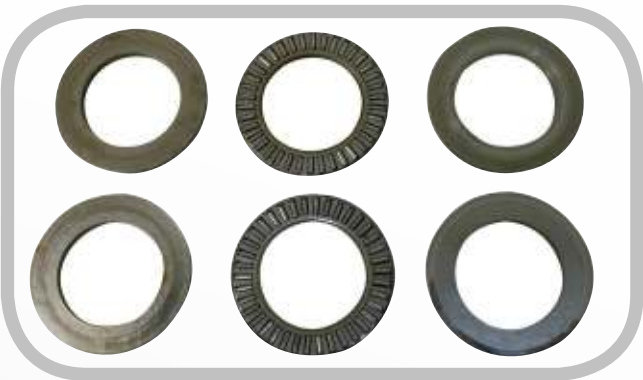
Thrust bearings and spacers

Showing normal wear with some slight scoring in the rear washers.

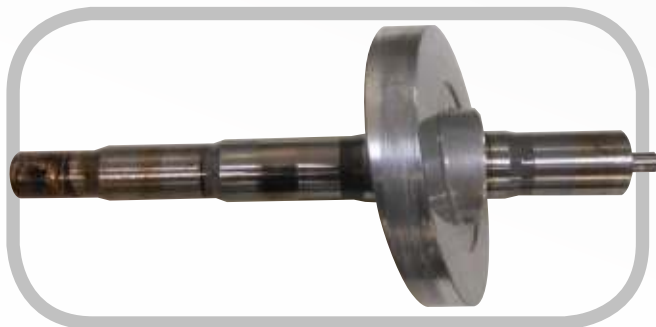
Swashplate

Nothing significant was found. Normal operational wear was visible on the plate and shaft.

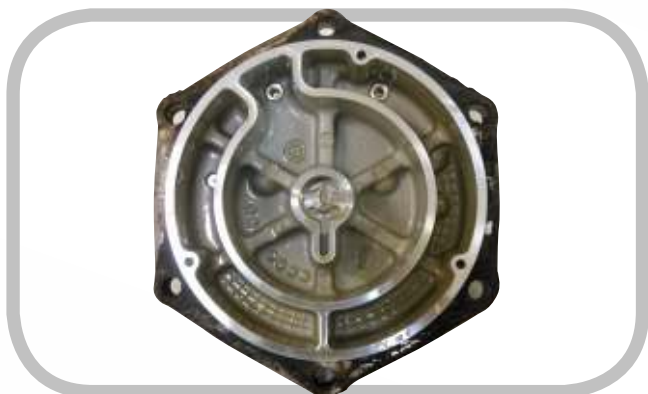
Rear cap

The rear cap and oil pump were both in good condition, with the rear cap showing some slight scoring in the oil pump chamber.

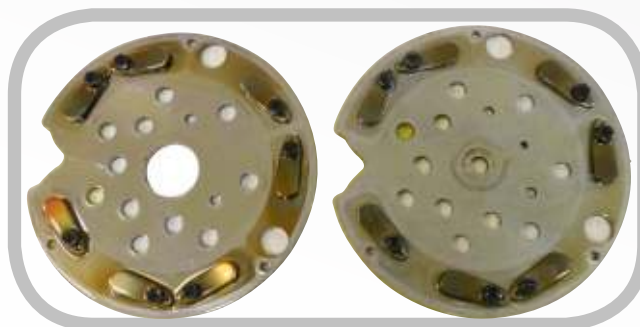
Swashplate

All valve plates were in excellent working order. There were some minor signs of excessive temperature or pressure during operation, with only some slight blackening on the discharge valve plate. This was most likely caused during periods of the system operating low on refrigerant from the leaking discharge line that was replaced twice during the period of service.

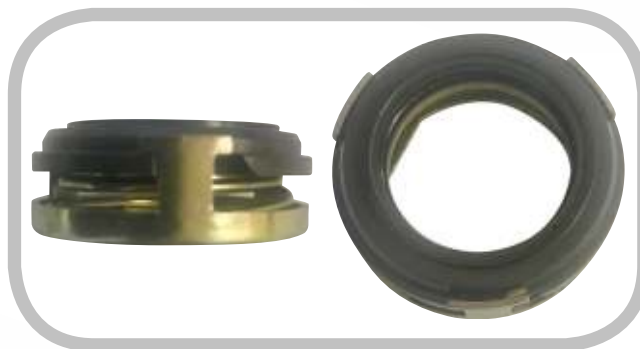
Shaft seal

The front nose cone is in good condition. The shaft seal was the main issue, causing a refrigerant leak. The reason appears to be a small chip/crack in the ceramic ring as shown in the images.

assembly of the compressor – are capable of further operation in the field. The compressor was only in need of a new shaft seal. With this replaced, and the clutch cleaned or replaced, the compressor is now ready to return to service.
