# UP115 compressor

Unicla Cat. No. T1701

An intense inspection was carried out on this compressor by the Unicla Australia team after they had been informed about a faulty system by A1 Auto Electrics & Airconditioning in Moree, NSW Australia.

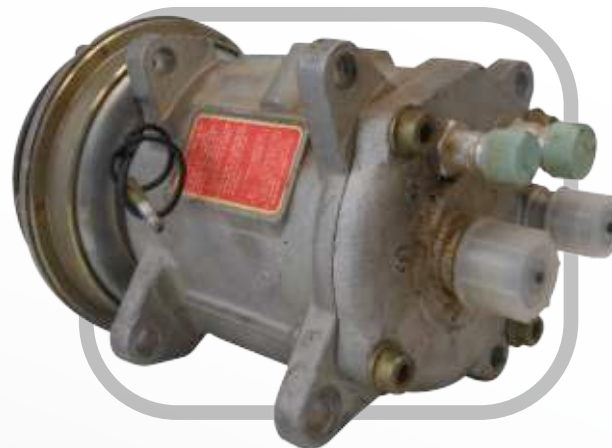
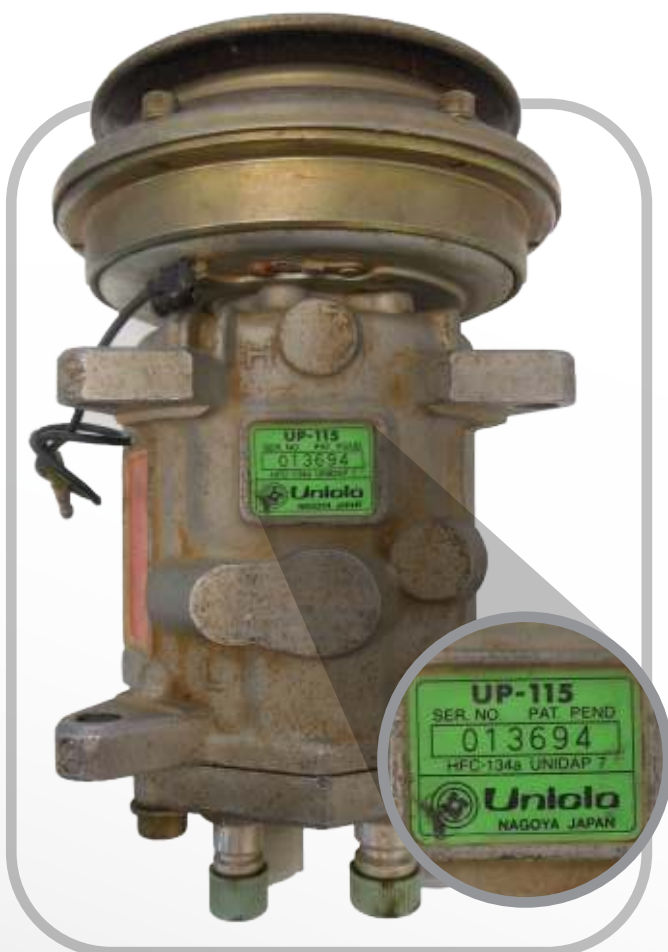
The compressor was pulled apart and each component tested individually. The working assembly, swash plate shaft, bearings , front and rear suction and discharge valves and seals were tested physically and visually. A leak test was

conducted to identify a possible leak on the body and/or the rear cap. And finally, the pistons and shoe discs were measured precisely to find the amount of wear to these parts due to the sliding and reciprocating friction from over 22 years operation.
