# UPF170 compressor

Cat. No. T1702

This report reveals the high temperature levels in the system caused from the low refrigerant conditions and how it impacted on the compressor. The main components affected are the shaft seal, rear cap housing and the rear oring. The final leakage at the heat fatigued oring resulted in the replacement of the compressor after six and a half years of service and 355,000km.

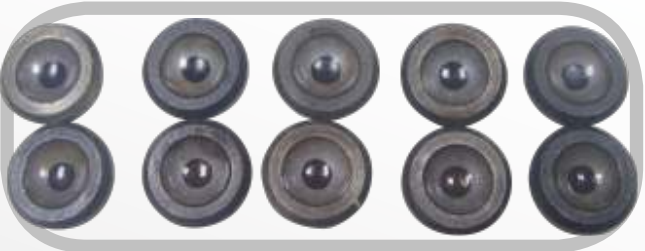
Shoe discs

**Clearance:** (Standard: 0.020 - 0.022). The sliding sides of the shoe discs are in good condition and within specification for their age. No damage to other parts of the discs and they could continue to function normally.

| Clearance | 1 | 2 | 3 | 4 | 5 |
| | 0.056 | 0.050 | 0.045 | 0.057 | 0.057 |

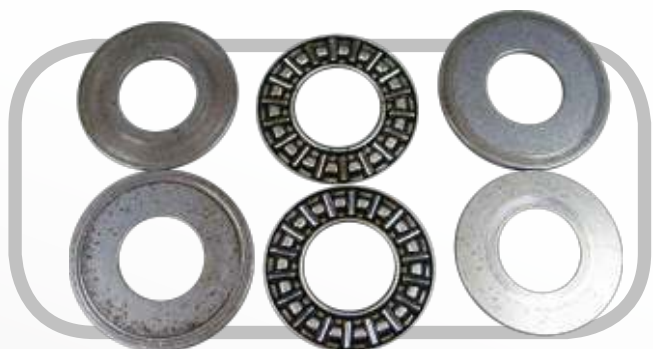
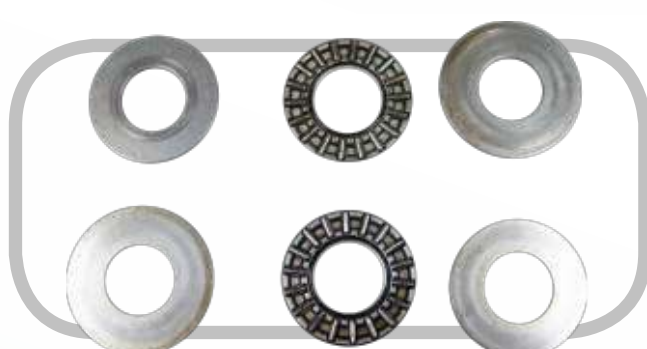
## Thrust bearings and washers

The major components of the compressor are still in excellent condition for this duration of operation. In particular the pistons, thrust bearings, shoes discs and swashplate are

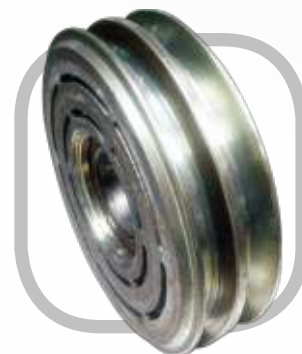
### Clutch pulley

Bearing is operational with slight roughness.

Small deformation from impact with another object, possibly during servicing or removal.
